Evaluation Report 323

Blackhawk 60 Heat Exchanger

BLACKHAWK 60 HEAT EXCHANGER

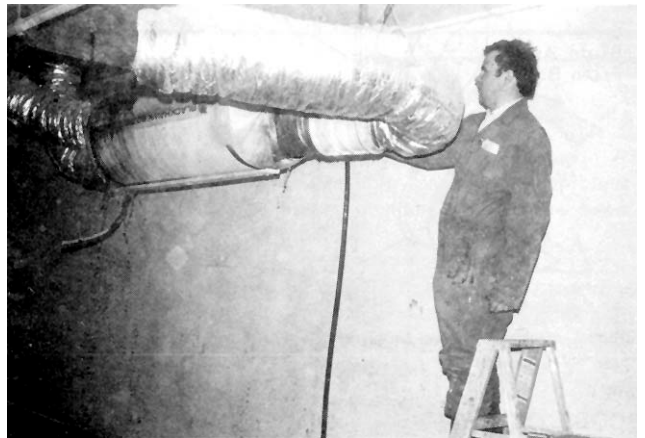
FIGURE 4. Washing with a Garden Hose.

The core of the Blackhawk 60 could only be washed with a low pressure (50 psi maximum) washer (FIGURE 4). Water was sprayed into the core from the exhaust inlet and outlet ports to rinse away dirt which had built up. Occasionally, the drain hose plugged with dirt, causing the rinse water to spill over the edges of the drip tray.

Washing the core as indicated in the operator manual was not completely effective. When the heat exchanger was removed at the end of the season, a thorough washing showed that a considerable amount of dirt had remained in the core in spite of regular washings.

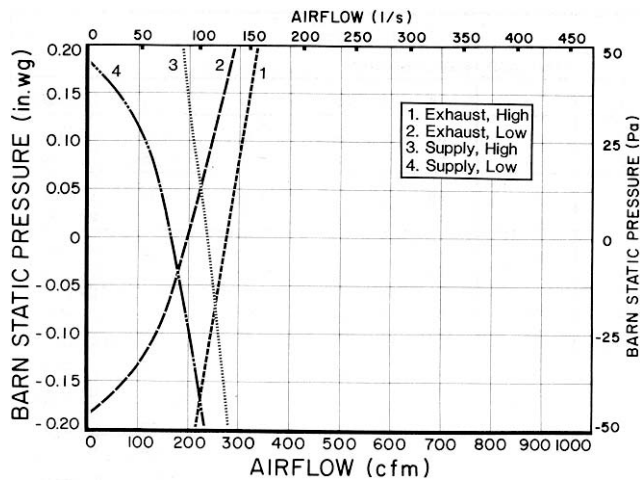
FIGURE 6. Heat Exchanger Airflow.

The performance³ of the Blackhawk 60 exhaust and supply fans for a typical installation⁴ is shown in FIGURE 6. The flow of standard air at the manufacturer's recommended operating static pressure of 0.00 in wg (inches water gage) (0 Pa) was 280 cfm (132 L/s) exhaust and 230 and 165 cfm (109 and 78 L/s) supply, with the fan on high and low respectively. These flow rates are for a typical installation. Less flow will be obtained for installations with longer ducts and more bends. Detailed fan curves are given in APPENDIX II to assist in calculating flows for different installations.

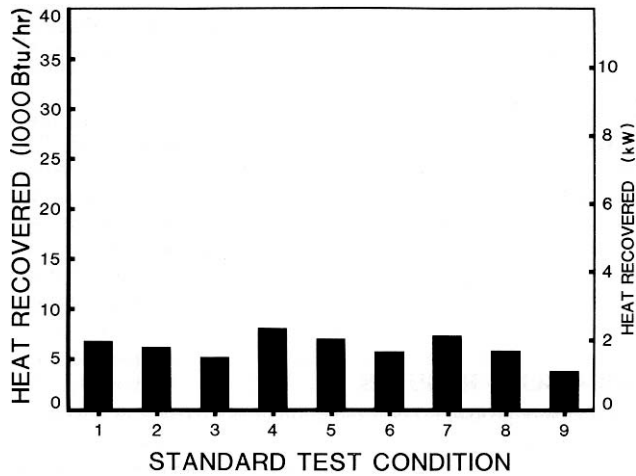
FIGURE 7. Average Heat Recovery.

The average heat recovery of the Blackhawk 60 at the manufacturer's recommended airflow settings⁵ varied from 3800 Btu/h (1.1 kW) to 8000 Btu/h (2.3 kW) as shown in TABLE 2 and in FIGURE 7.
